New Hampshire Building at Eastern States Exposition

NEW HAMPSHIRE BUILDING

Preliminary Chapter 34 Investigation & Evaluation Report

March 5, 2020

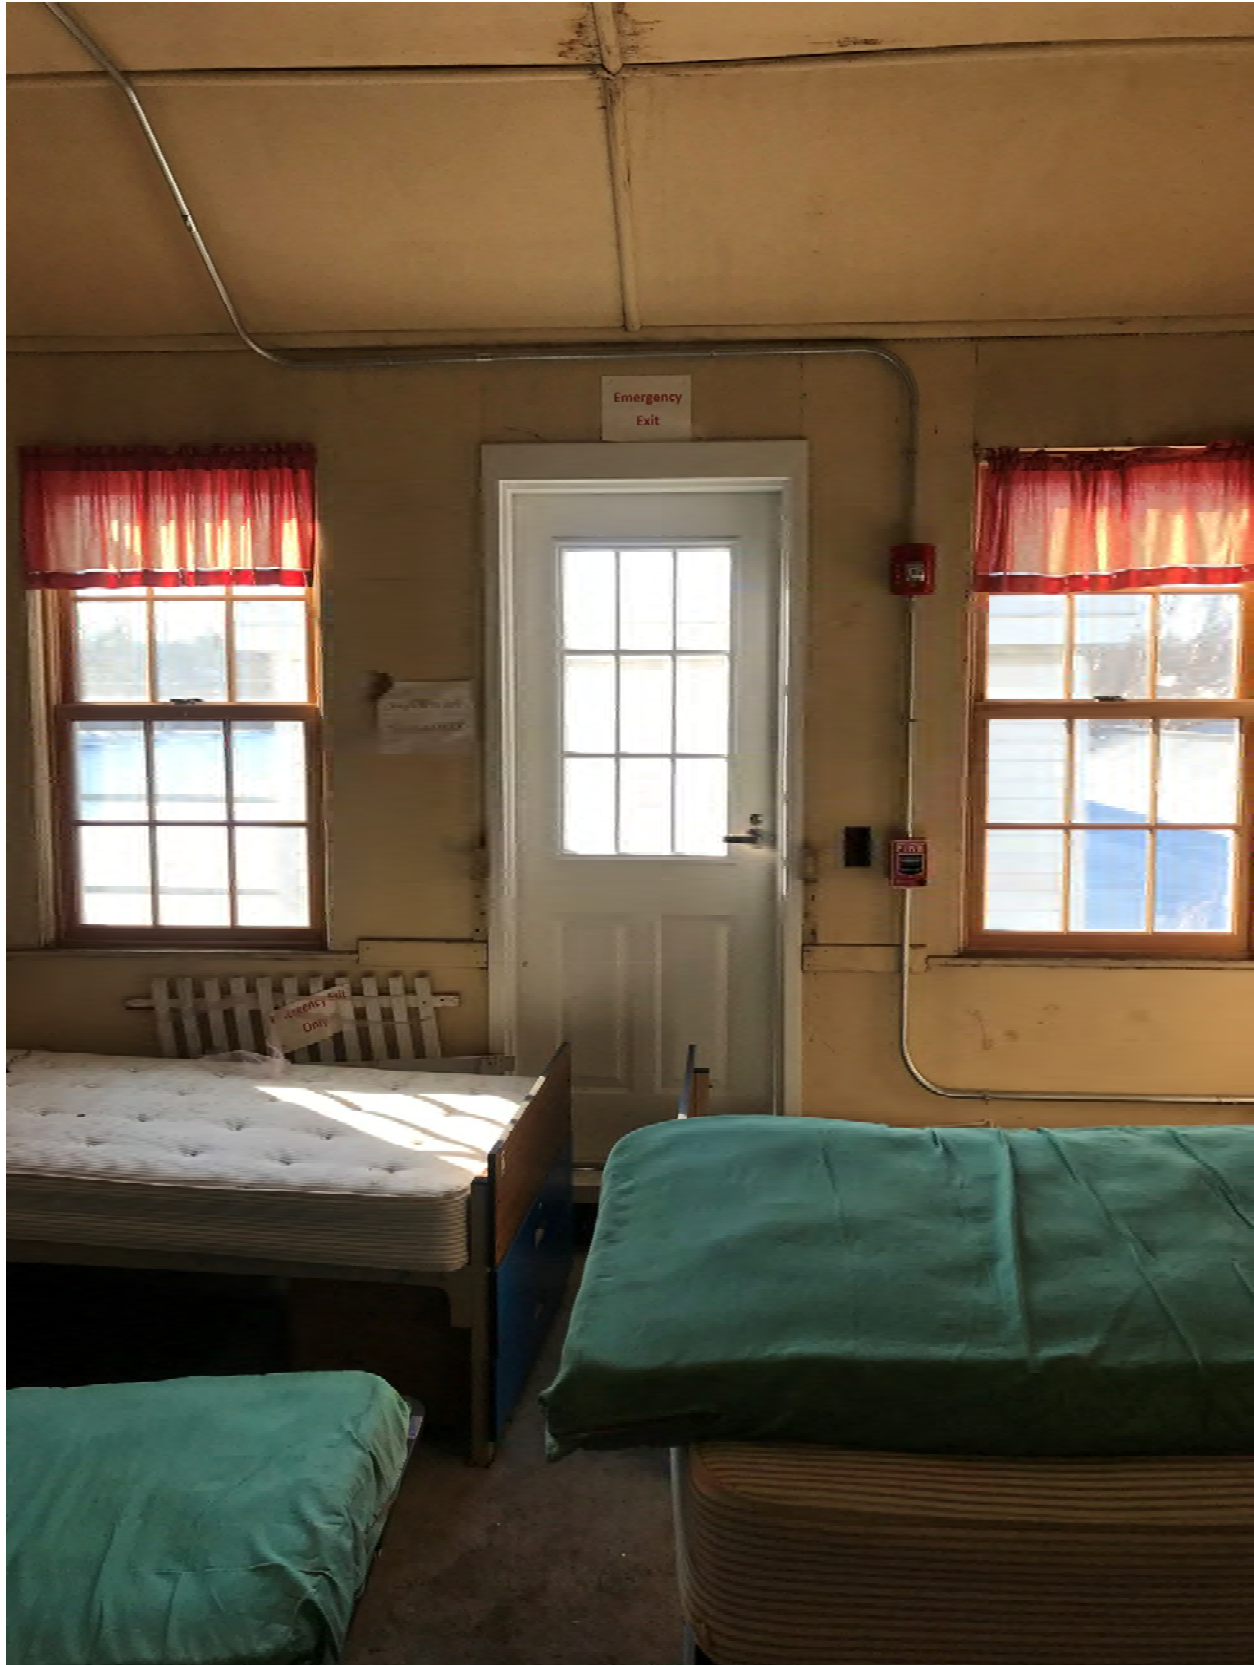
Figure 1 - Obstructed Door and Noncompliant Exit Sign

1. Minimum 36" clear aisles should connect all exit doors and the stairs. This path must be maintained unobstructed at all times.
2. While the steps up to the roof must remain, contrasting marking and warning signs should be provided.
3. All dead bolts should be removed from doors.
4. All knobs should be replaced with lever type handles.
5. Additional emergency egress lighting should be provided to ensure the minimum lumens are provided at the floor (1 foot-candle at the floor) and the emergency lighting is provided for the path across the roof and at the exit discharges.
6. Replace all paper exit signs with internally illuminated exit signs.
7. Remove all storage from the 3rd and 2nd Floors.

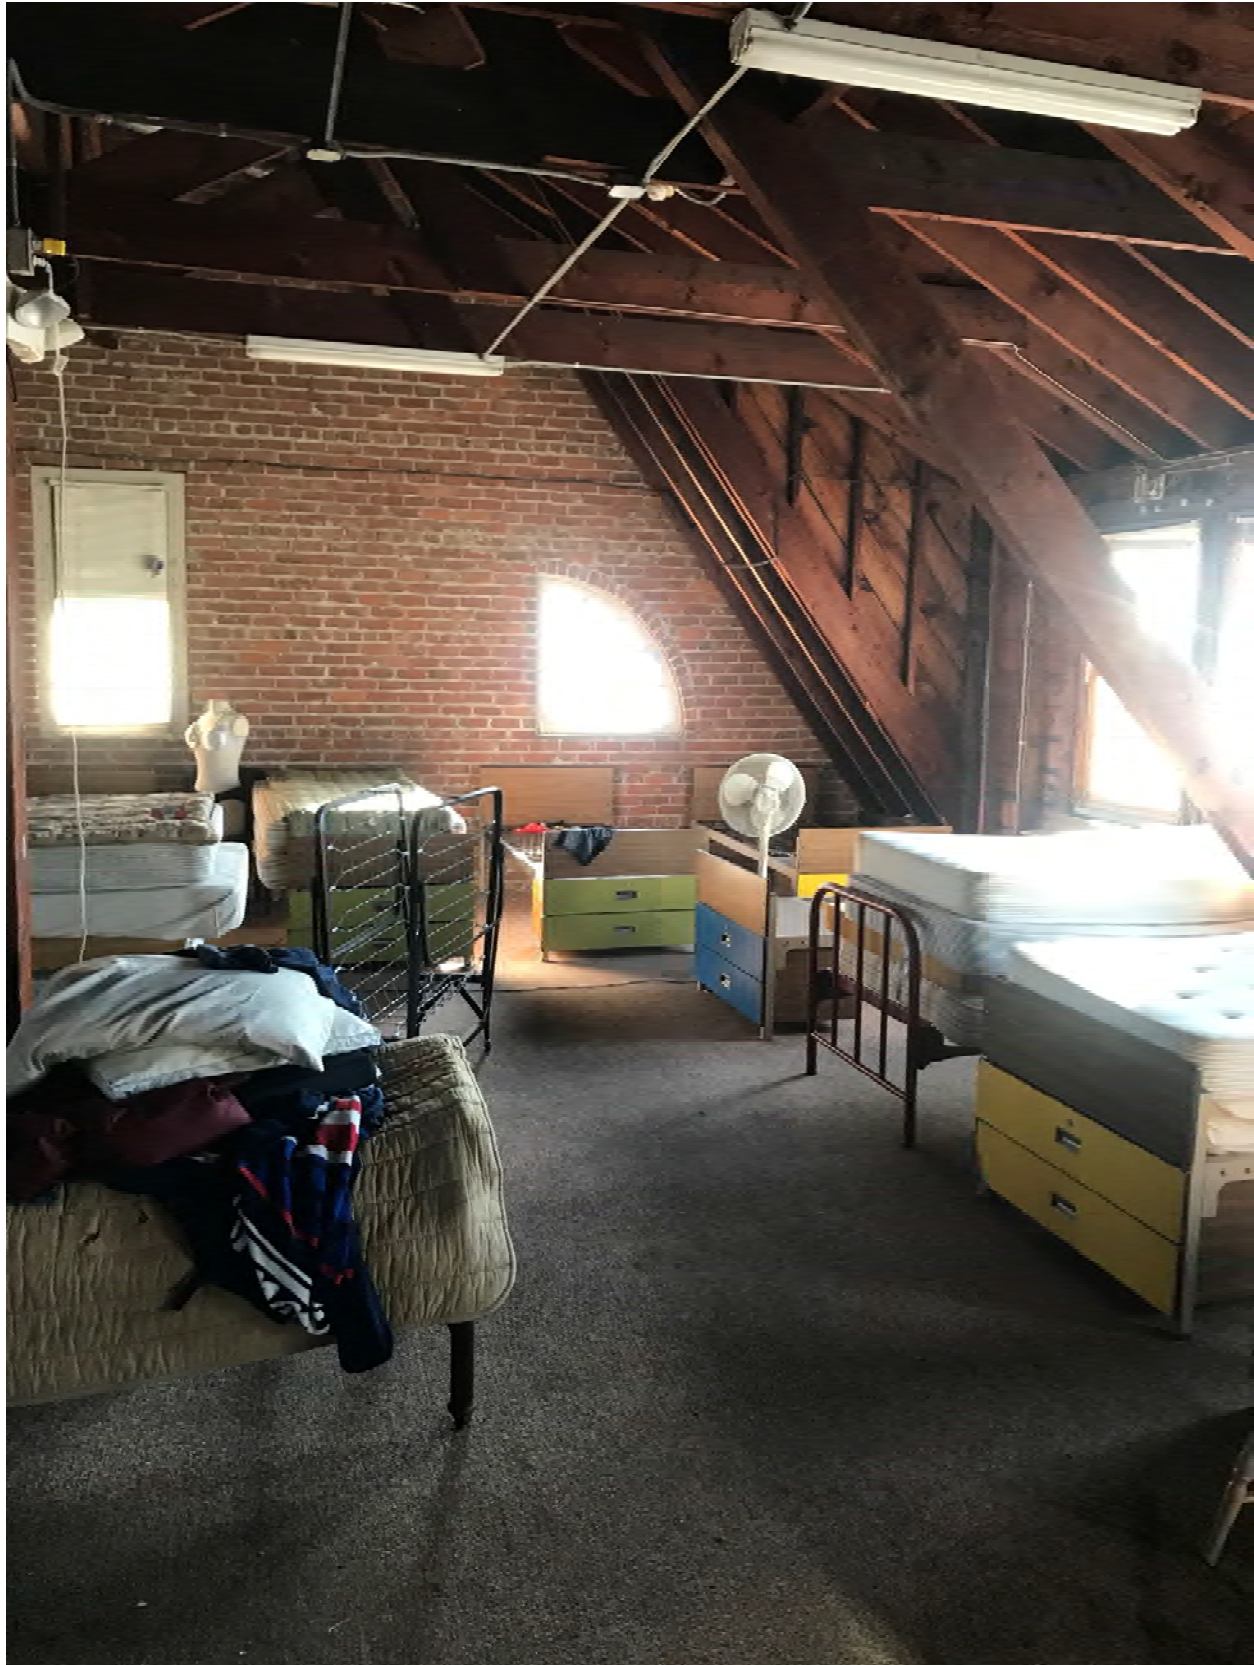
1. The limited aisle accessways provided between beds to reach the exit doors from each sleeping room,
2. Steps up to the roof right at the doors,
3. Door hardware,
4. Emergency egress lighting, and
5. Exit Signage.

Figure 3 - Exit Aisles between Beds is Insufficient

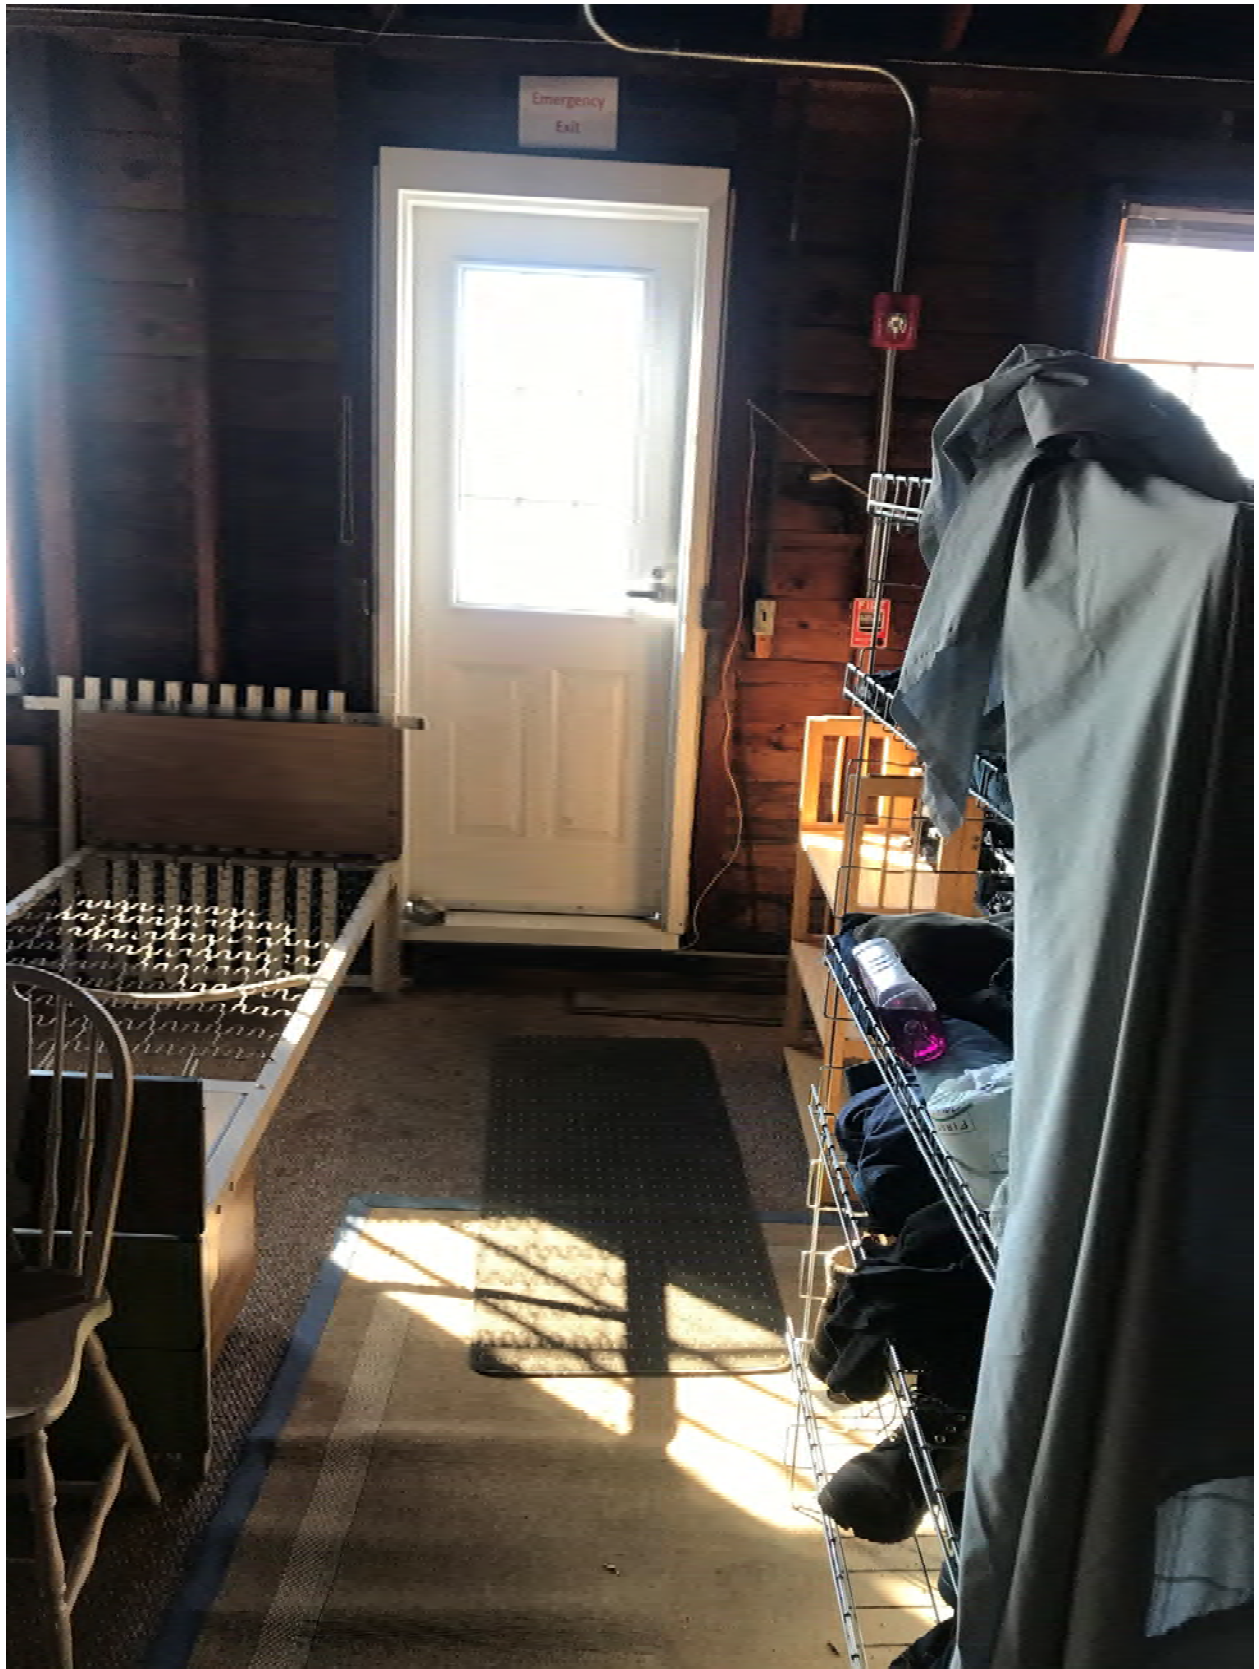
Figure 4 - Another Exit Door Obstructed and Noncompliant Exit Sign

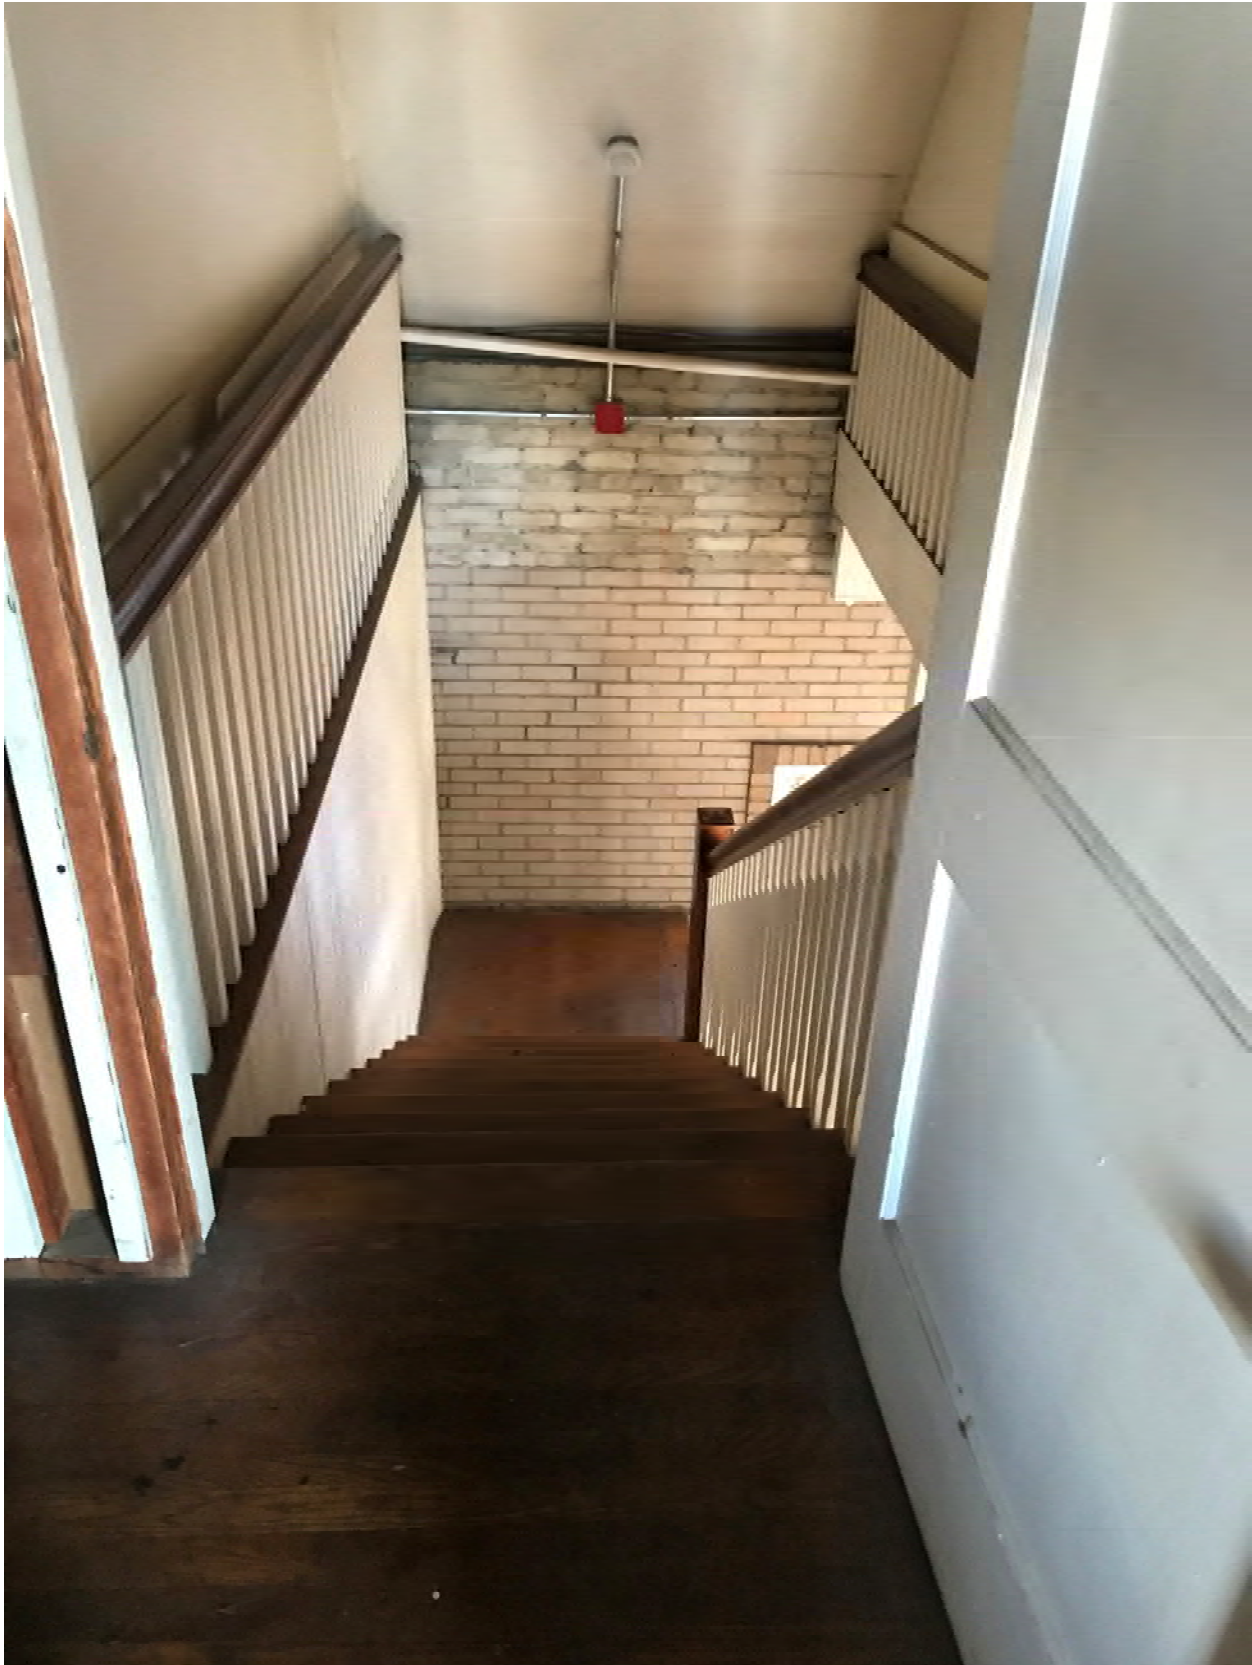
Figure 5 - Internal Stairway 1 and Enclosure which is not Smoke-Tight

8. Replace outdated fire escape with a full size exterior stairway.
9. Create smoke tight partitions between each sleeping room and between the 2nd and 3rd Floors. Namely doorways should be replaced to create tight fitting barriers at the internal stairways and the doorways separating the sleeping rooms from the other areas of the 3rd Floor.
10. Improve Stairway guardrails by increasing height to 42".
11. Retrofit automatic sprinkler protection throughout the 3-story portion at a minimum, but throughout the exhibition hall as well.

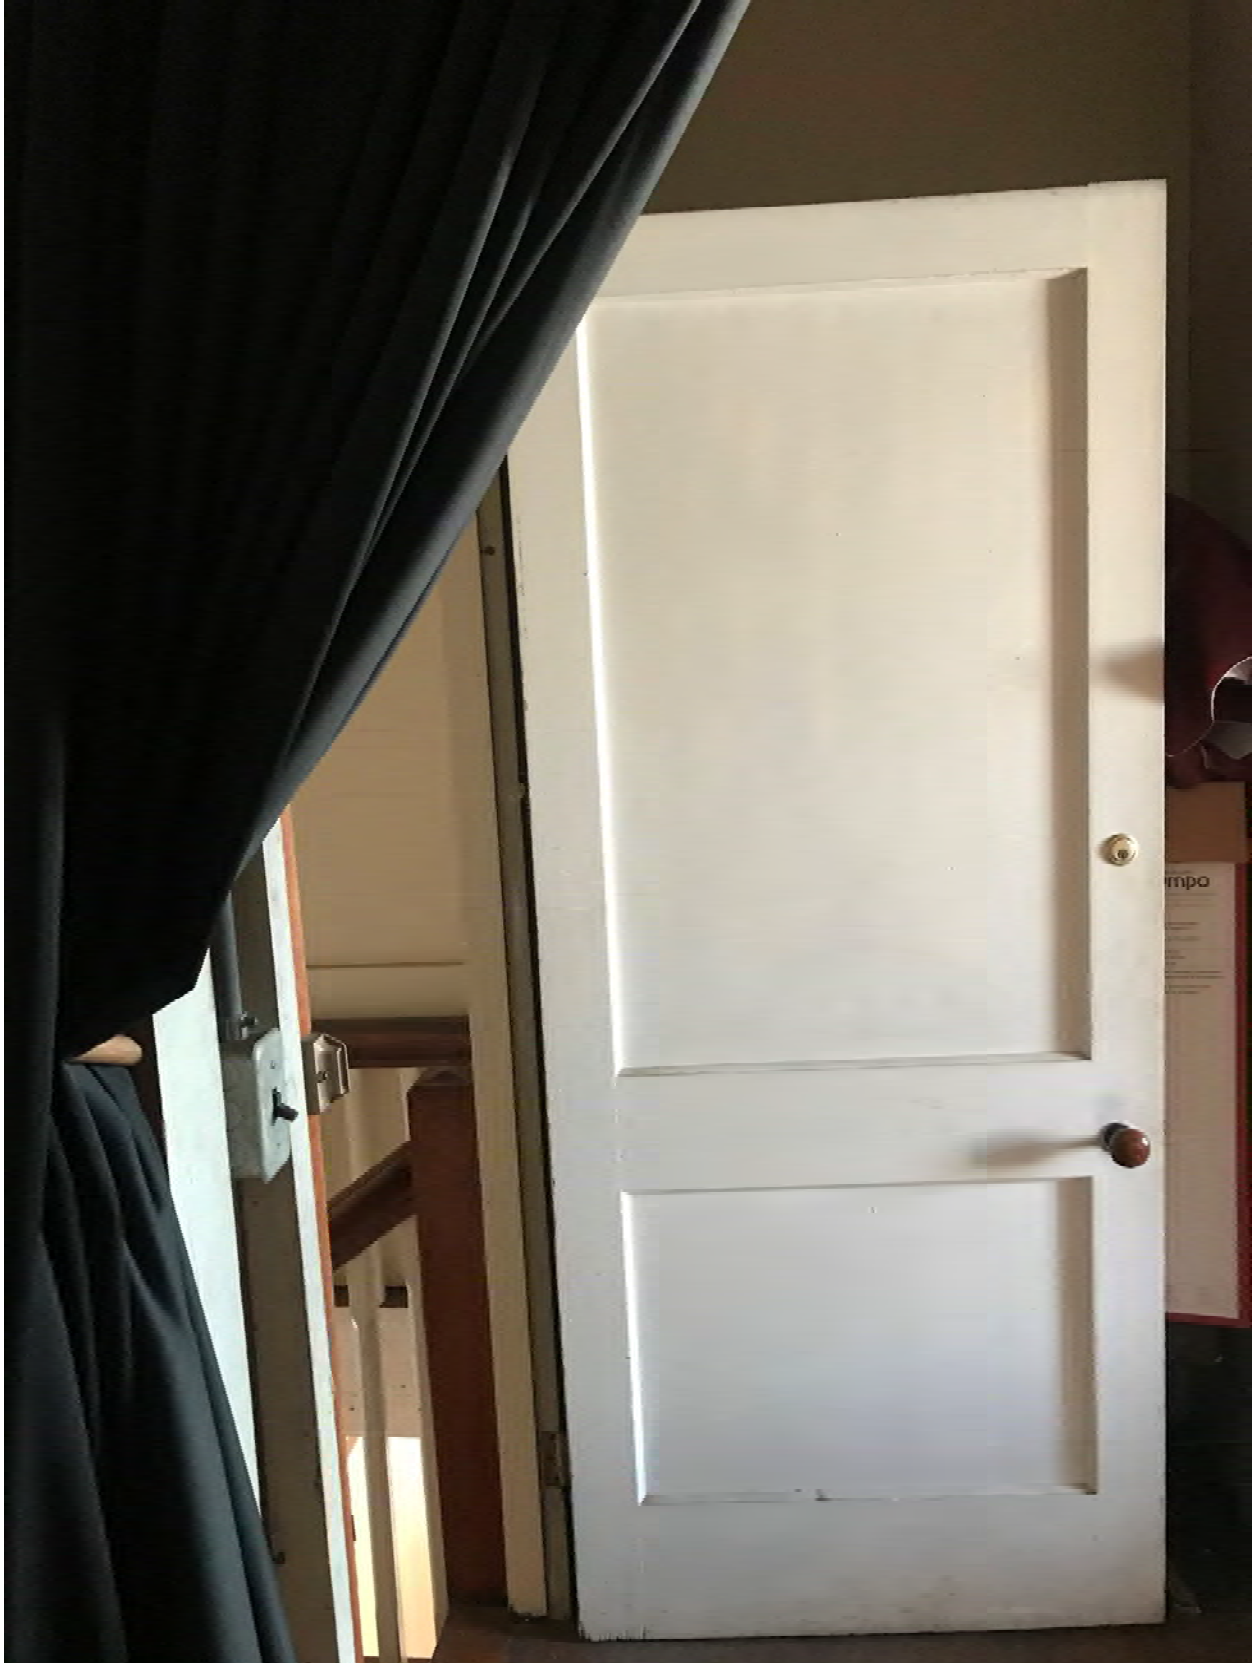
Figure 6 - Noncompliant door hardware and Unpermitted Dead Bolt

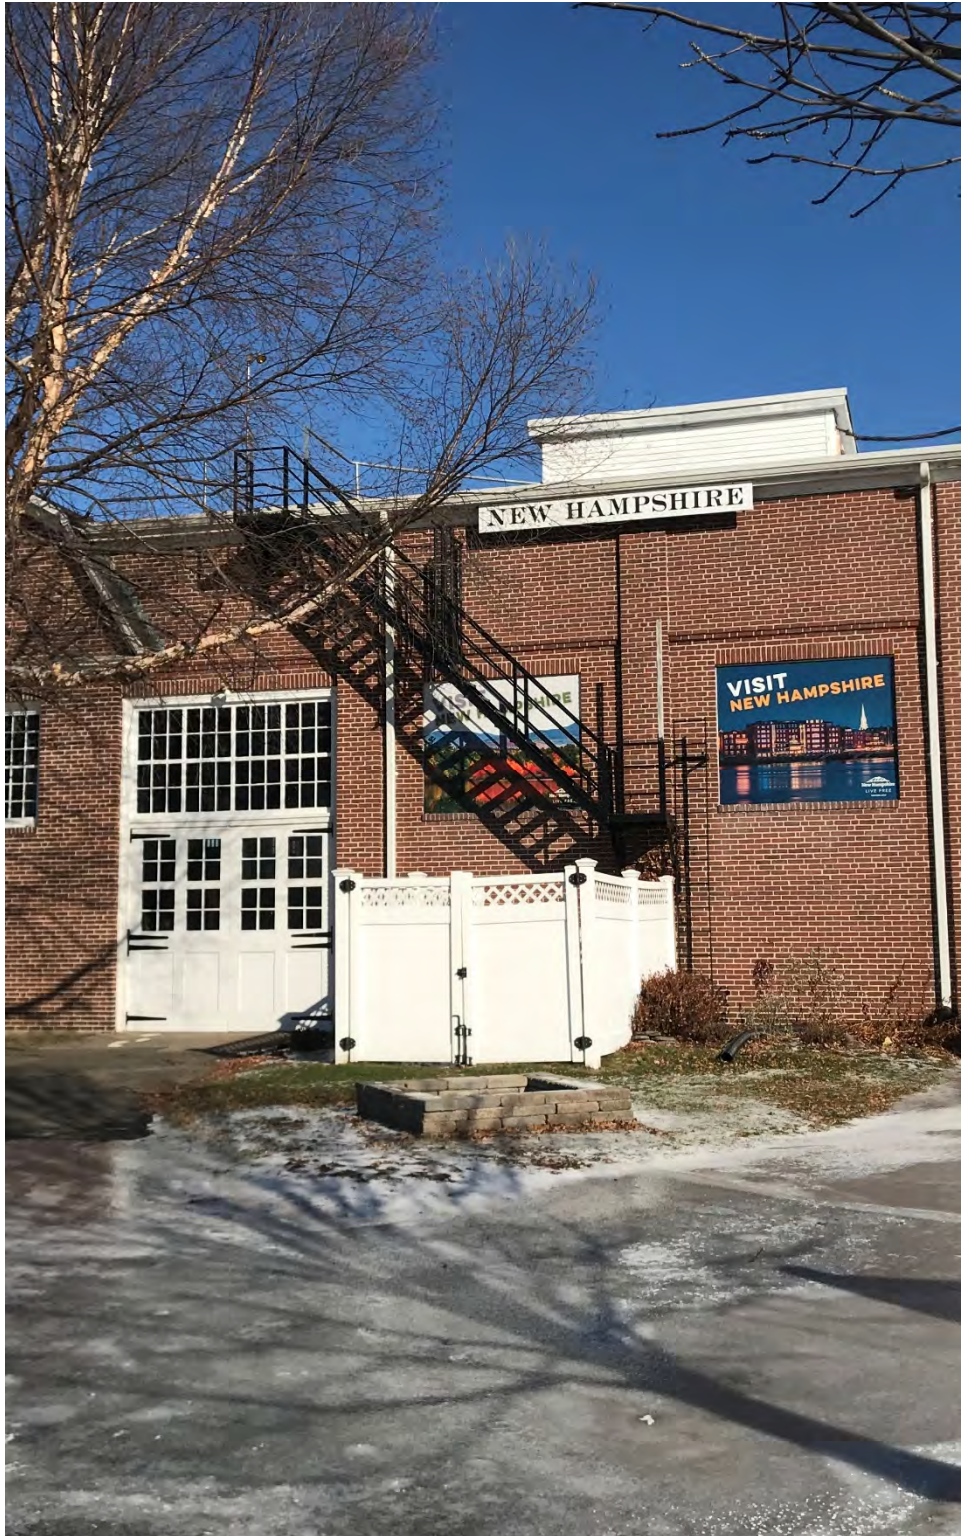
Figure 12 - Fire Escape at Rear of Building

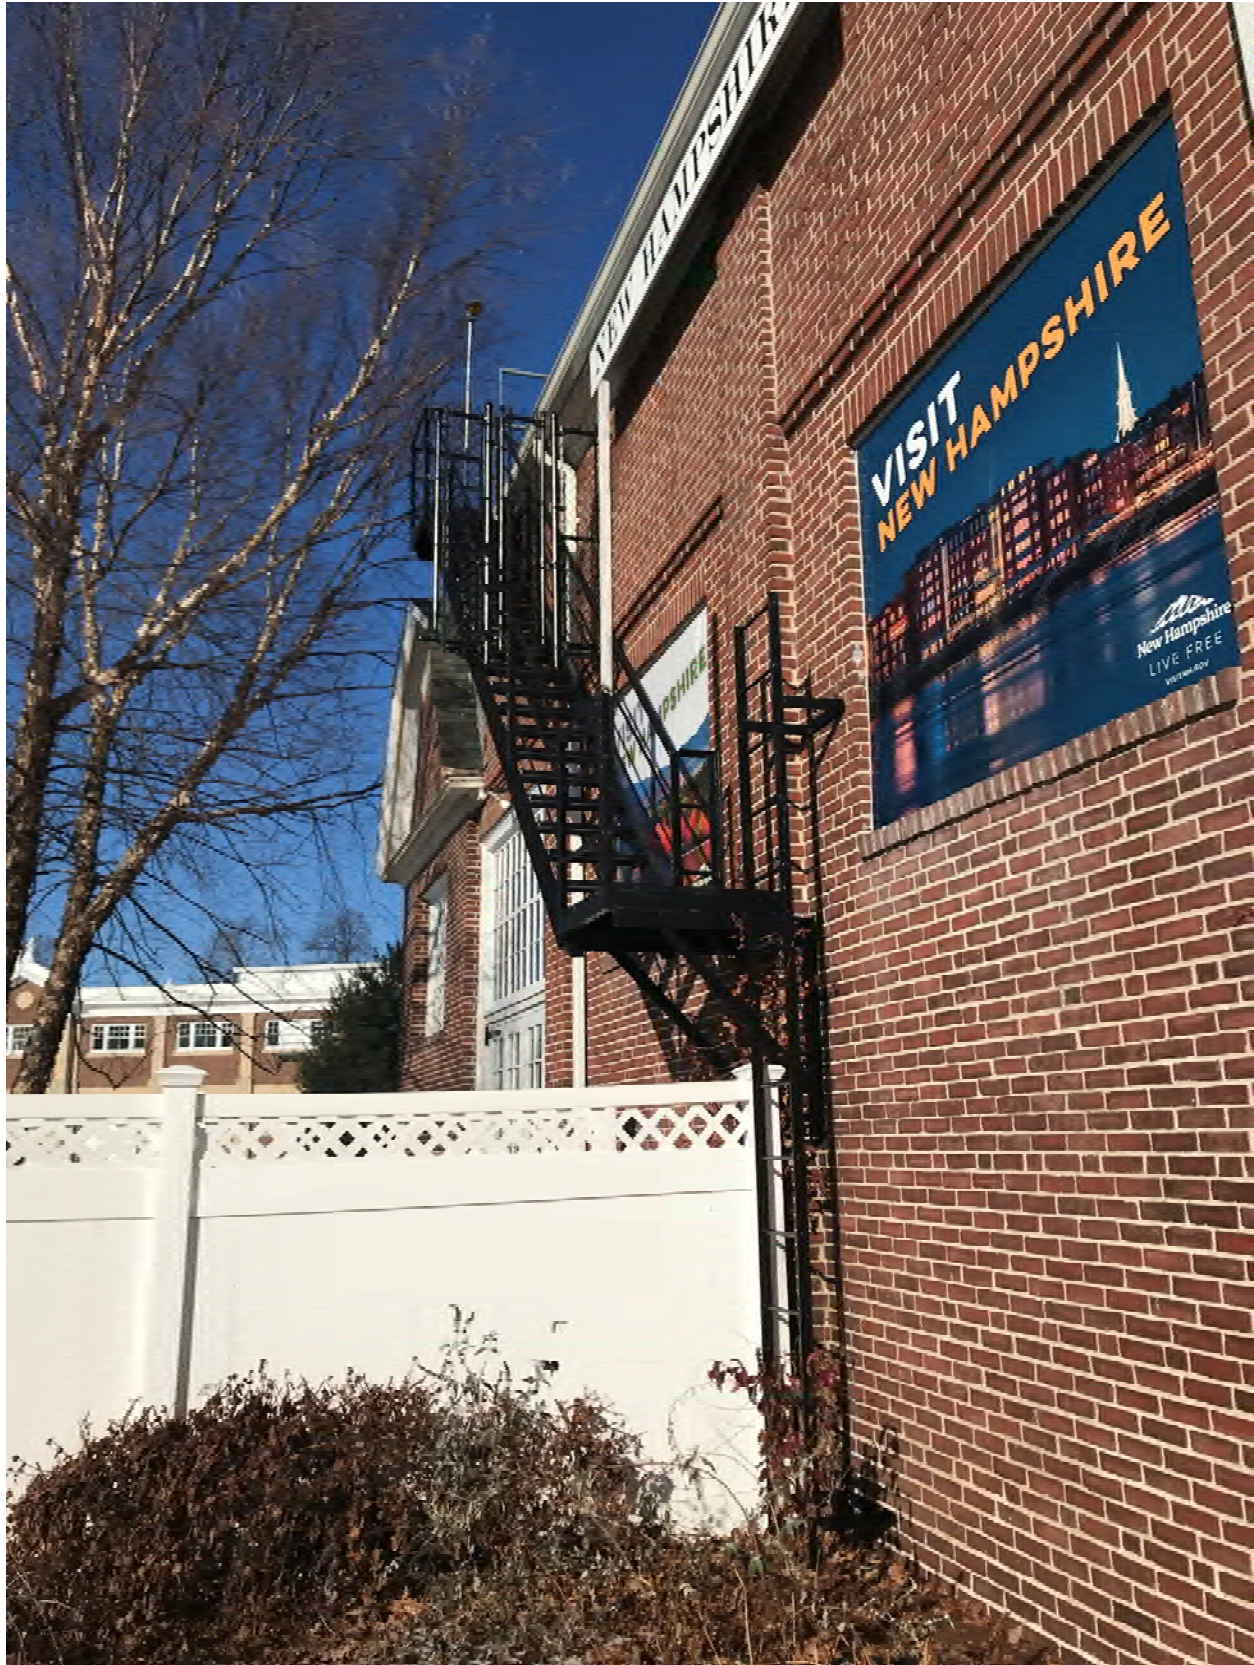
Figure 13 - Fire Escape at Rear of Building
