DOVER  
WATER WORKS

# Seacoast Drinking Water Commission

April 23, 2021

# Dover Water System

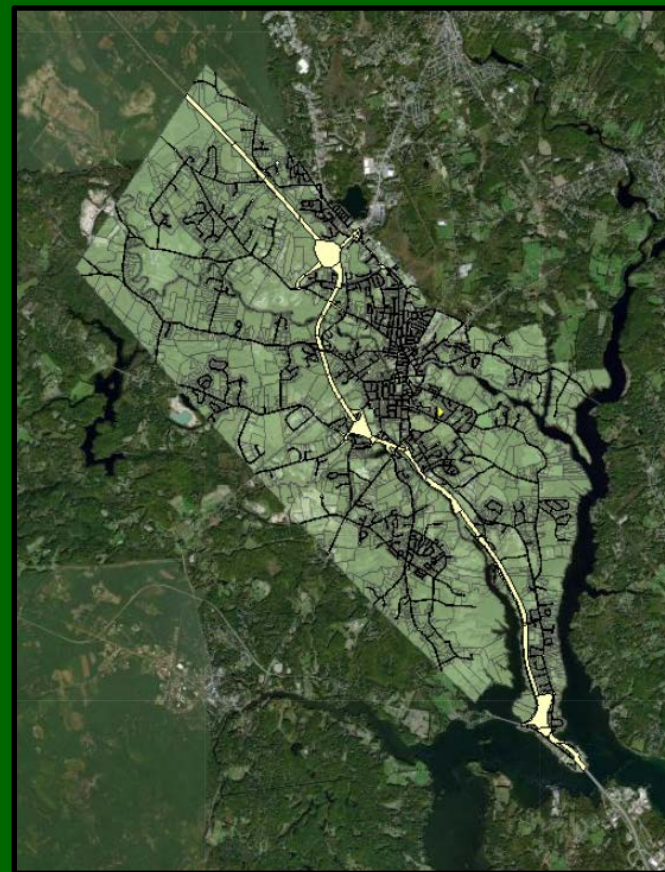
- **30,000 population (approx. 80% with public water)**
- **1.8 to 2.4 mgd**
- **All groundwater**
- **11 wells in 4 Aquifers**
- **2 artificial recharge**
- **3 treatment facilities**
- **2 storage tanks**
- **2 pressure zones**
- **1 booster station**
- **1 interconnect with Somersworth**
- **Approx. 780,000 lf water main**
- **Approx. Asset Value = \$200 Million**

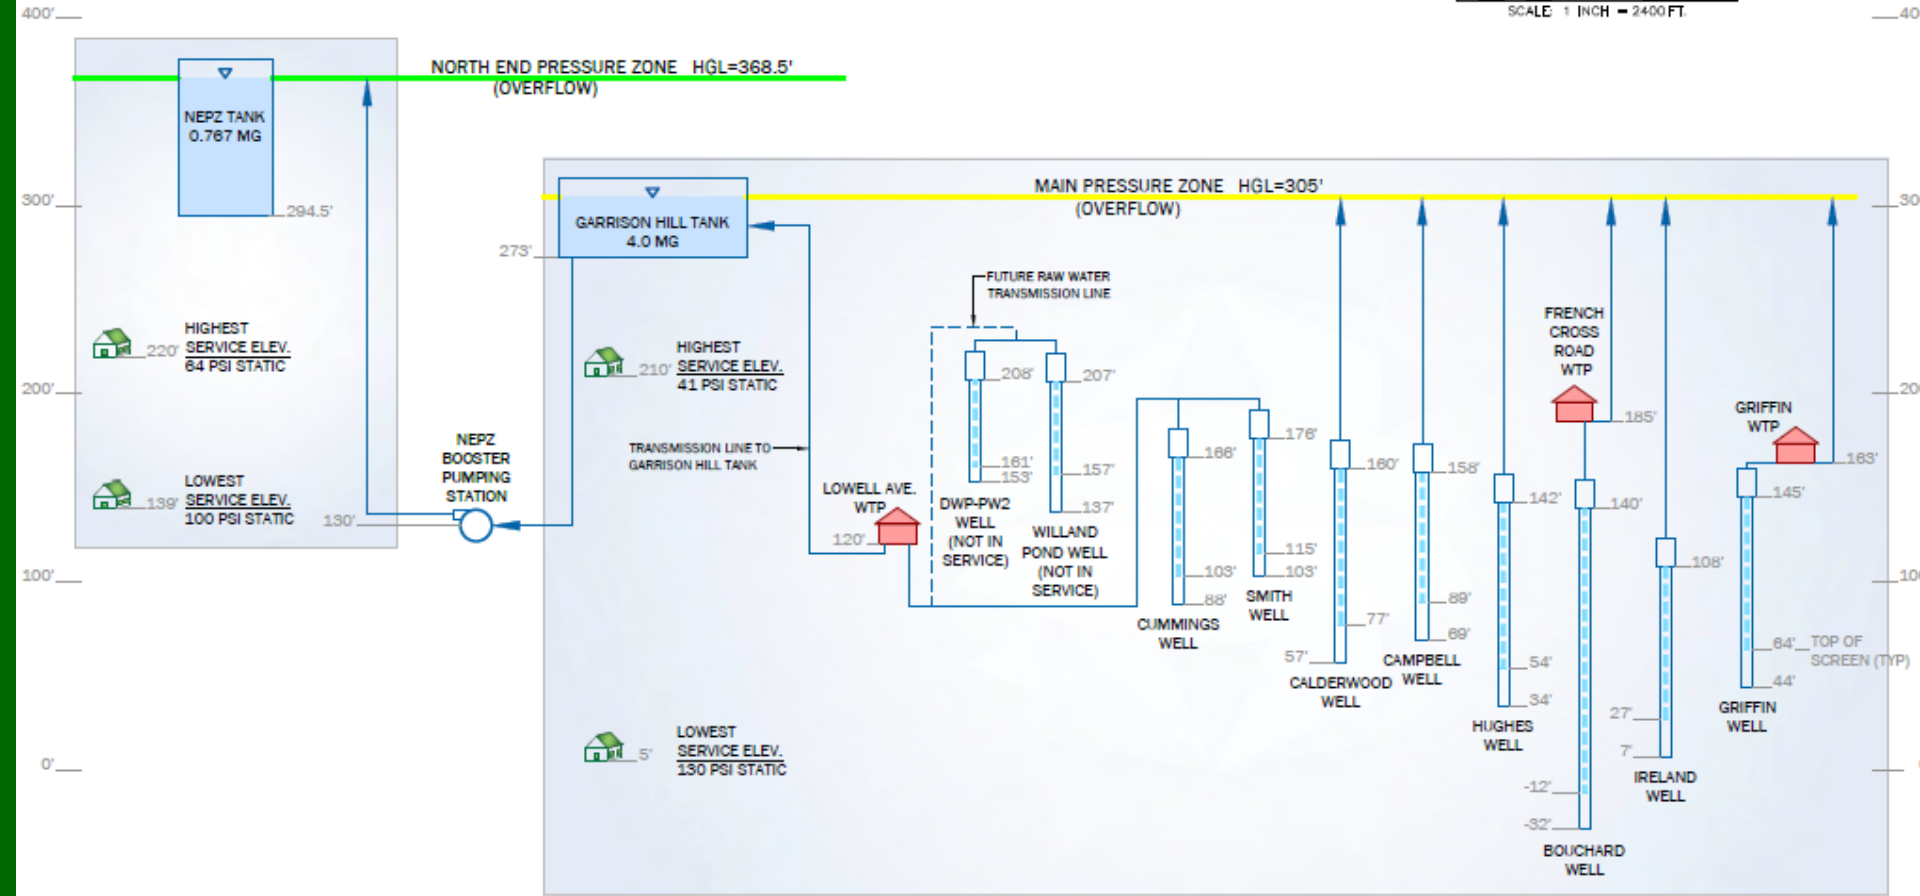
# Two Presser Zones (2012)

SCALE 1 INCH = 2400 FT.

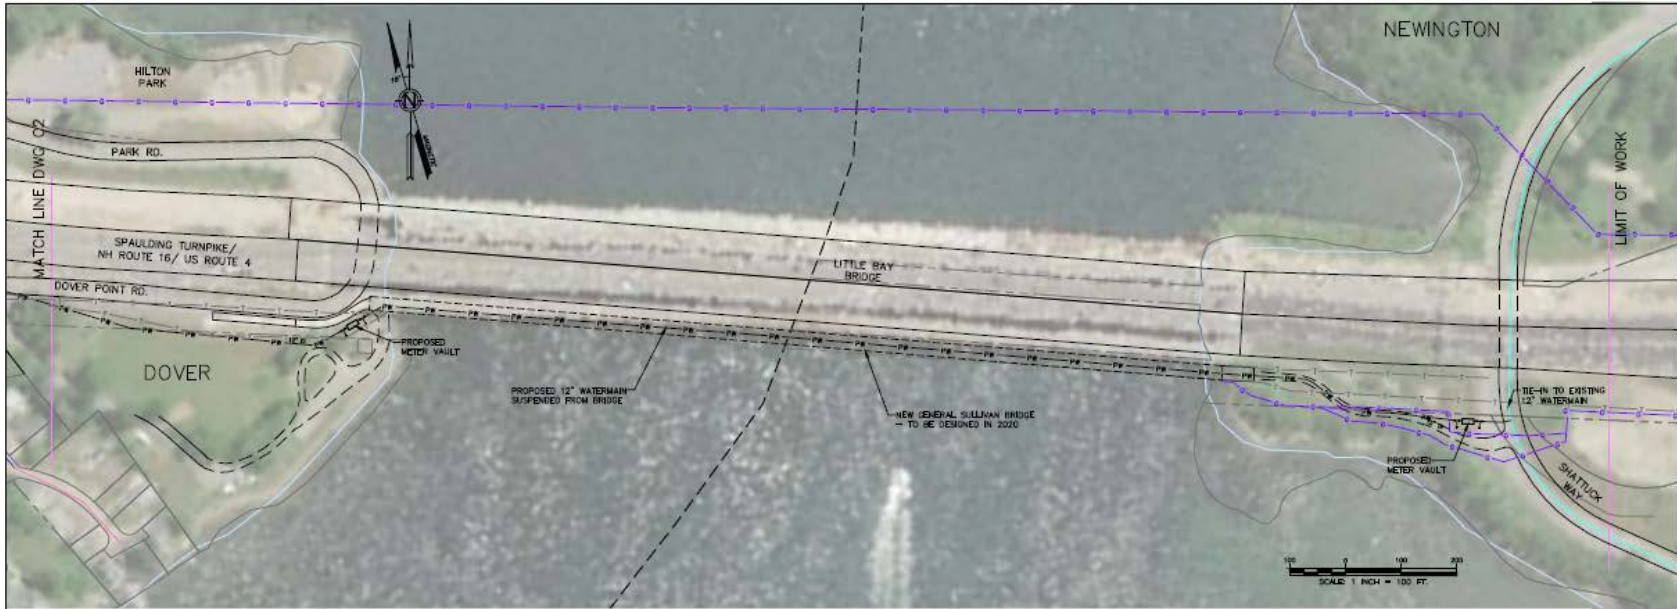
PIPE SUPPORT OPTIONS

**DOVER POINT INTERCONNECTION #1**  
**PORTSMOUTH EMERGENCY WATER INTERCONNECTIONS**  
**CITY OF DOVER**  
**DOVER, NEW HAMPSHIRE**

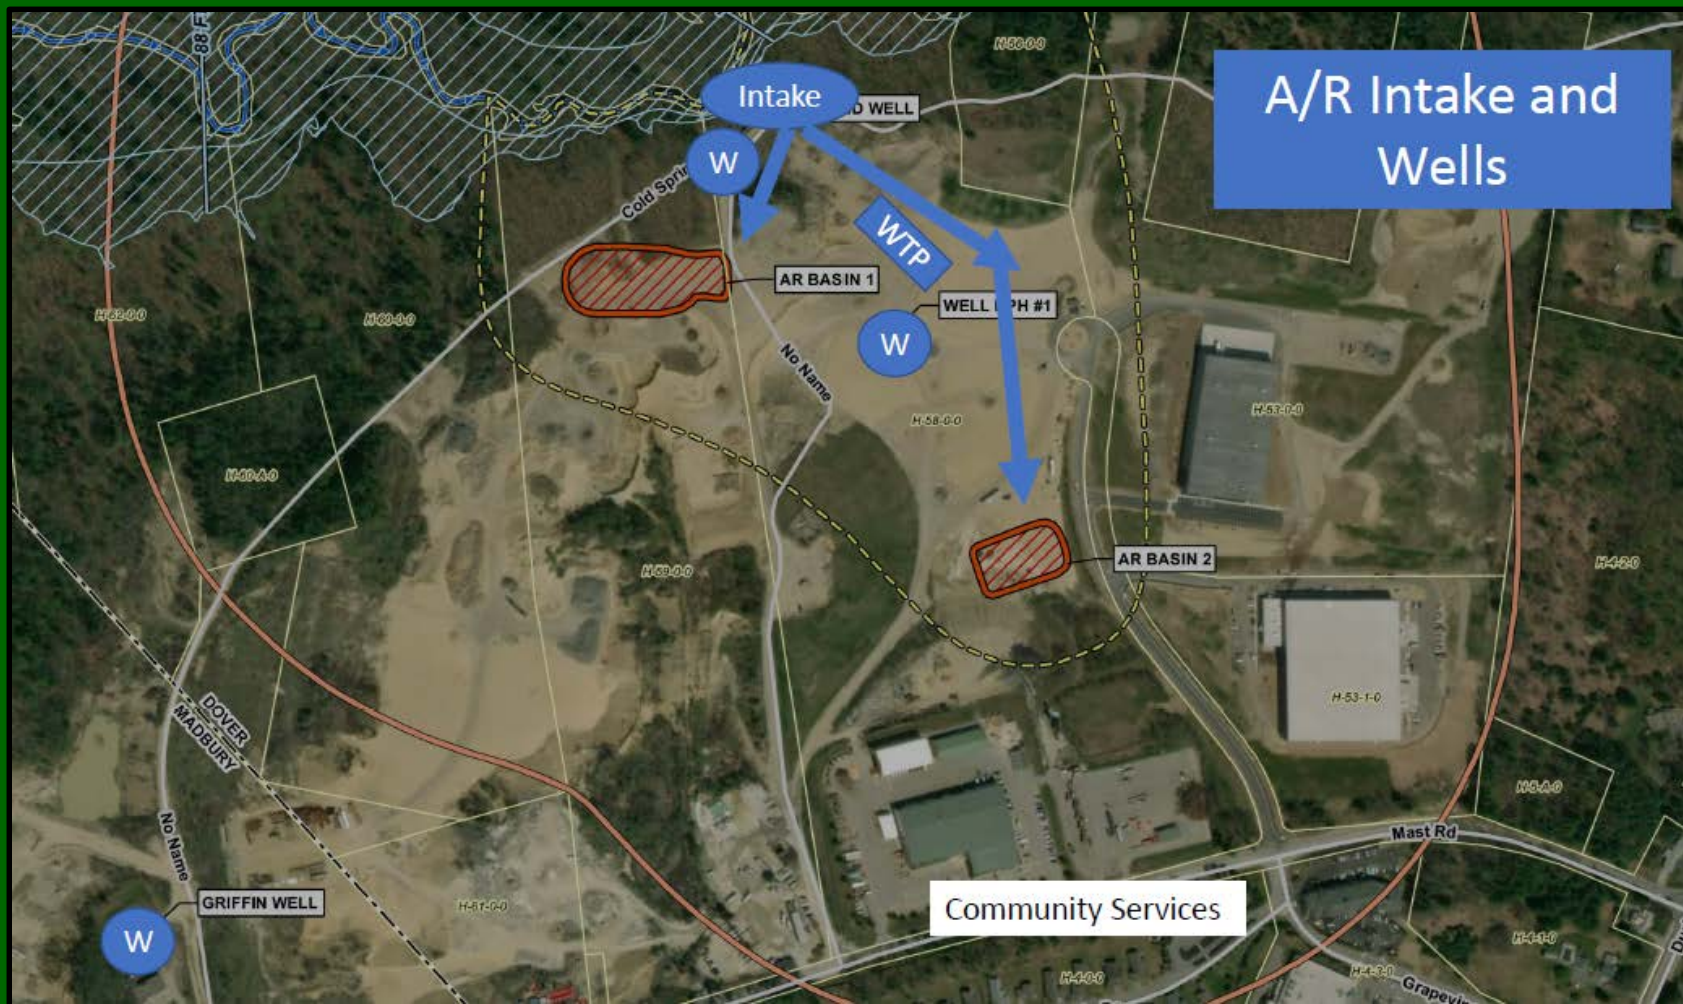
# Pudding Hill – Source of Contaminants

Contaminant	MCL	Griffin Well	Ireland Well	DPH-1 Well	
<b>PFAS (ppt)</b>					
PFHxS	18	24.7	50.7	4.66	8.14
PFOA	12	84	106	4.42	9.51
PFNA	11	ND	ND	ND	ND
PFOS	15	217	173	ND	2.02
MtBE (pbb)	13	1.6	1.9	ND	
1,4 Dioxane (pbb)	0.32	0.59	1.2	0.34	
Fe (mg/L)	0.3	0.40	0.19	0.315	
Mn (mg/L)	0.05	0.30	0.238	0.059

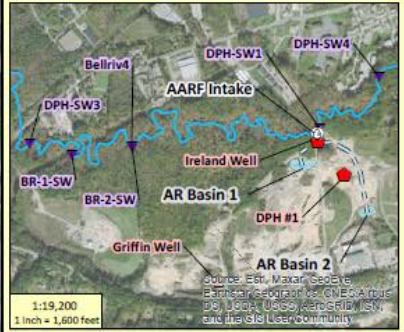
**FIGURE 3**  
**Emery & Garrett**  
Groundwater Investigations, A Division of GZA

**FIGURE 3**  
Monitoring Locations  
401 WQC Monitoring and Operations Plans  
Bellamy River Artificial Recharge Facility  
Dover, New Hampshire

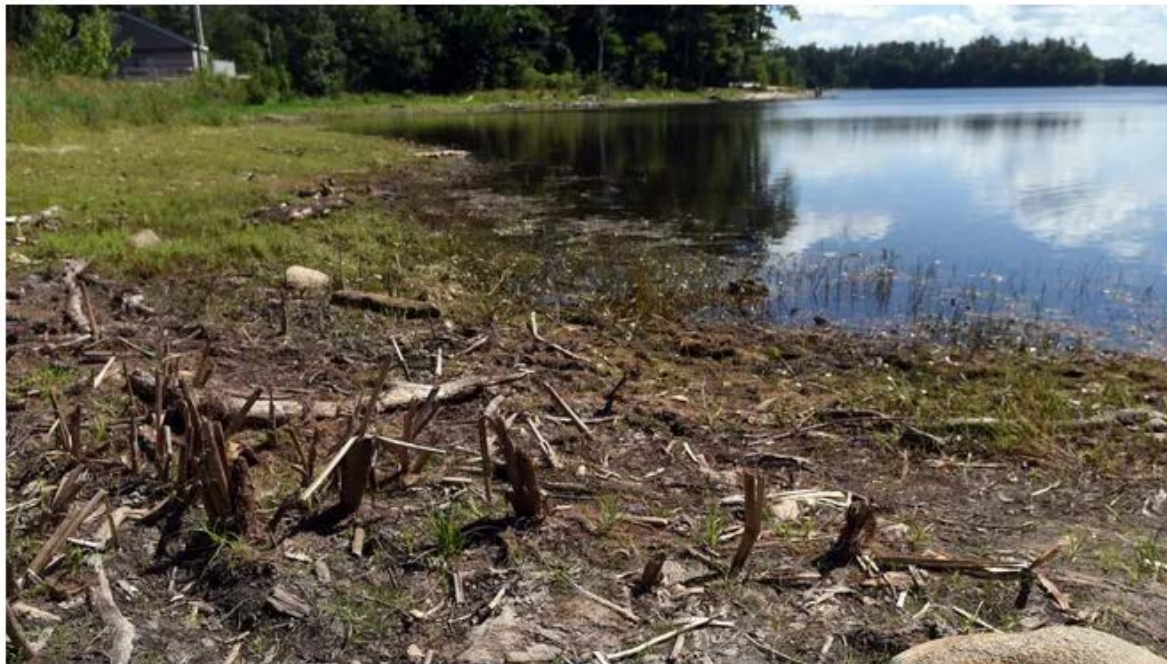
Water levels are low, as seen recently on the Dover side of Willand Pond, due to the lack of rain this summer. *Deb Cram/Fosters.com, File*
